Case Study

PNA JOINT STABILIZERS IMPROVE WAREHOUSE OPERATIONS

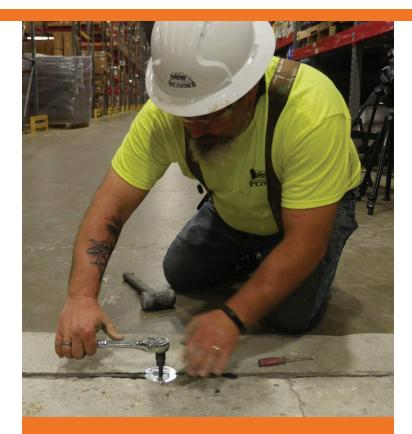
After evaluating the alternatives, the auto parts supplier chose to conduct a trial using the Joint Stabilizer system to see if it would resolve the distribution center's joint deflection problems. The company installed the stabilizers in 10 loose joints in 2005. Crews placed four stabilizers at each joint intersection and spaced others every 4 feet along the joints and in a few cracks.
